# maintenance management order

**SUBJECT:** Potential Hazard Freight Elevator Gate  
Counterweight Connecting Bolt

**NO:** MMO-064-99

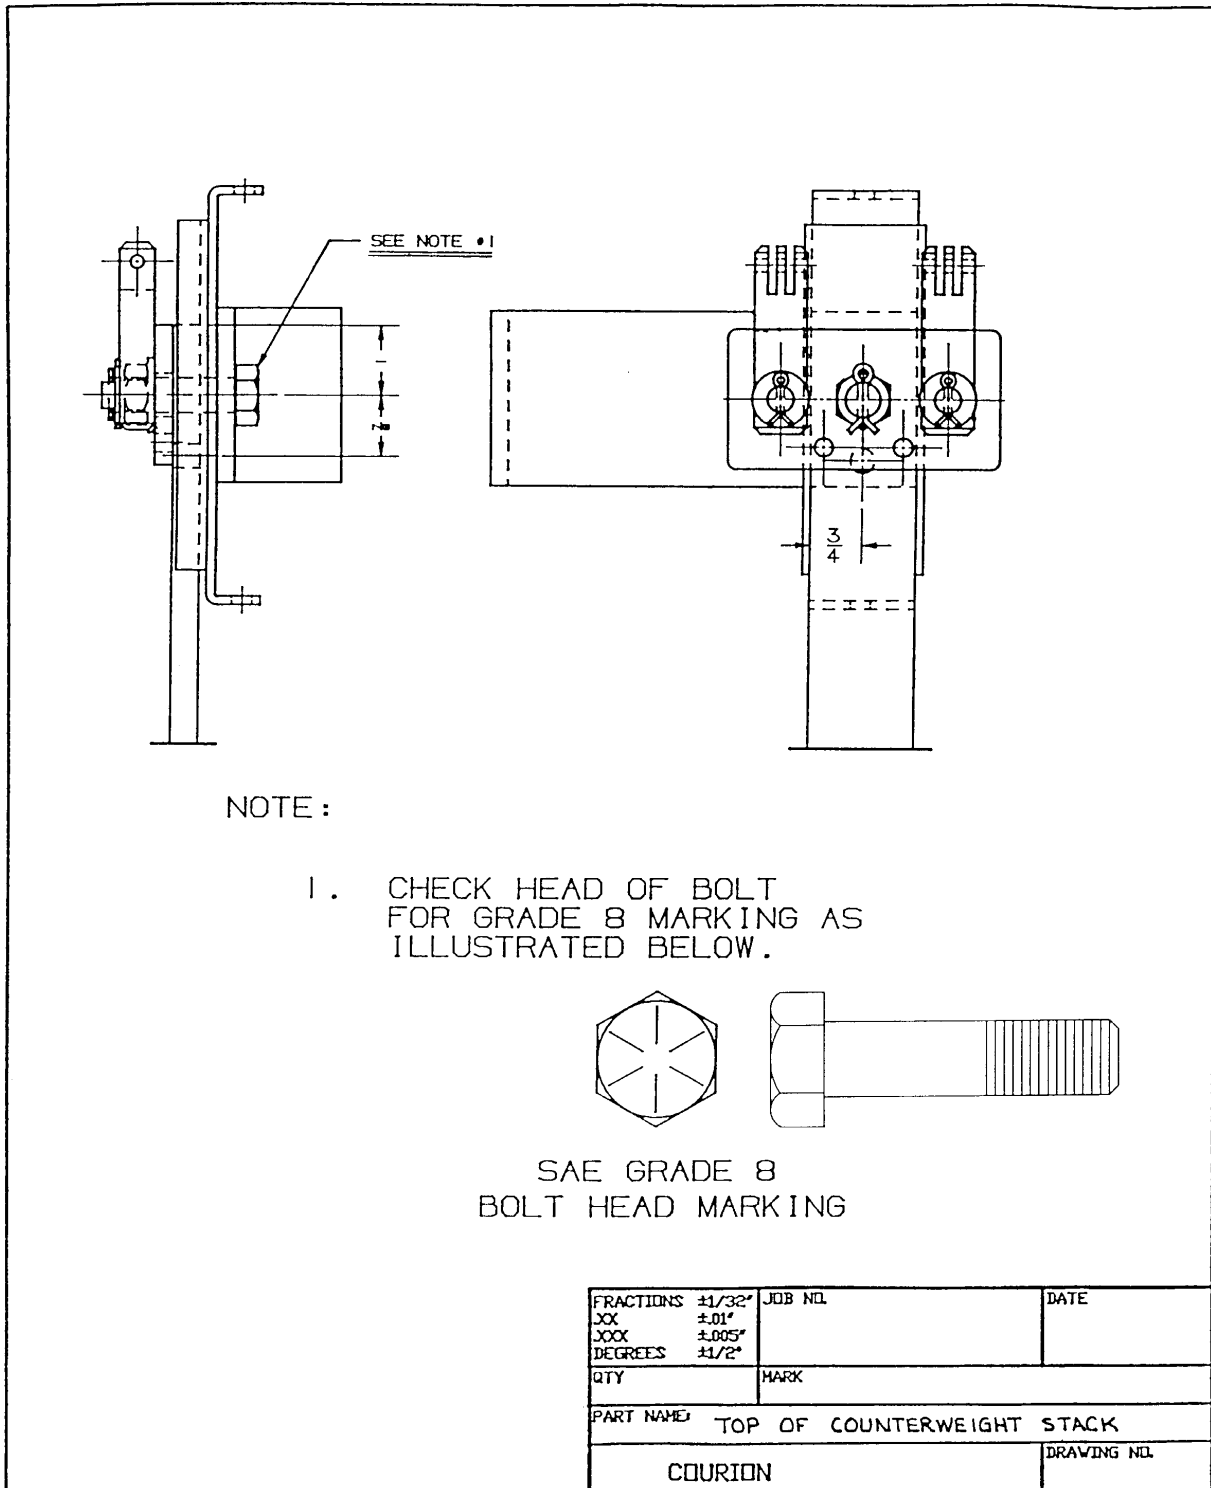
Figure 2. Location of Counterweight Bolt and SAE Grade 8 Bolt Marking

A qualified elevator mechanic, authorized to enter a hoistway using appropriate hazardous energy control procedures, should examine the connecting bolt for wear and to ensure the bolt is SAE Grade 8 or higher.

Figure 1 shows the location of a typical gate counterweight connecting bolt assembly. Figure 2 provides detail of the bolt location and typical SAE Grade 8 bolt head marking. Figure 3 provides an example of a worn, non-SAE Grade 8 bolt. Figure 4 provides an example of the gate counterweight connecting bolt assembly.

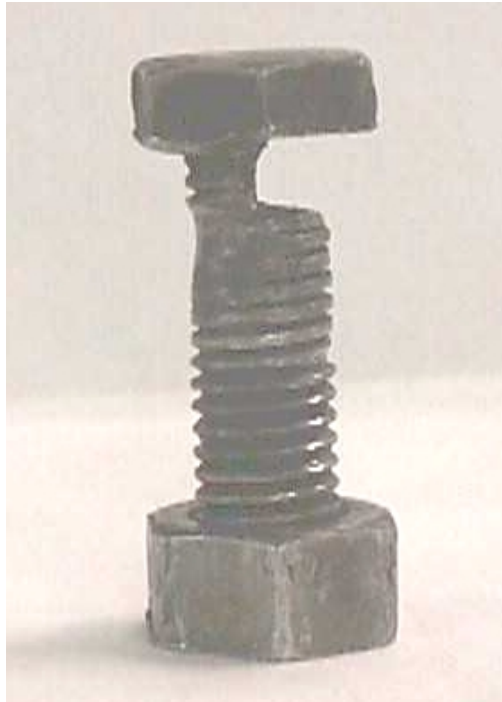
**Figure 3. Worn Non-SAE Grade 8 Bolt**

The design of these gates may pose a hazard with the connecting bolt for the gate counterweight. Failure of this bolt can result in the freight car gate closing unexpectedly.

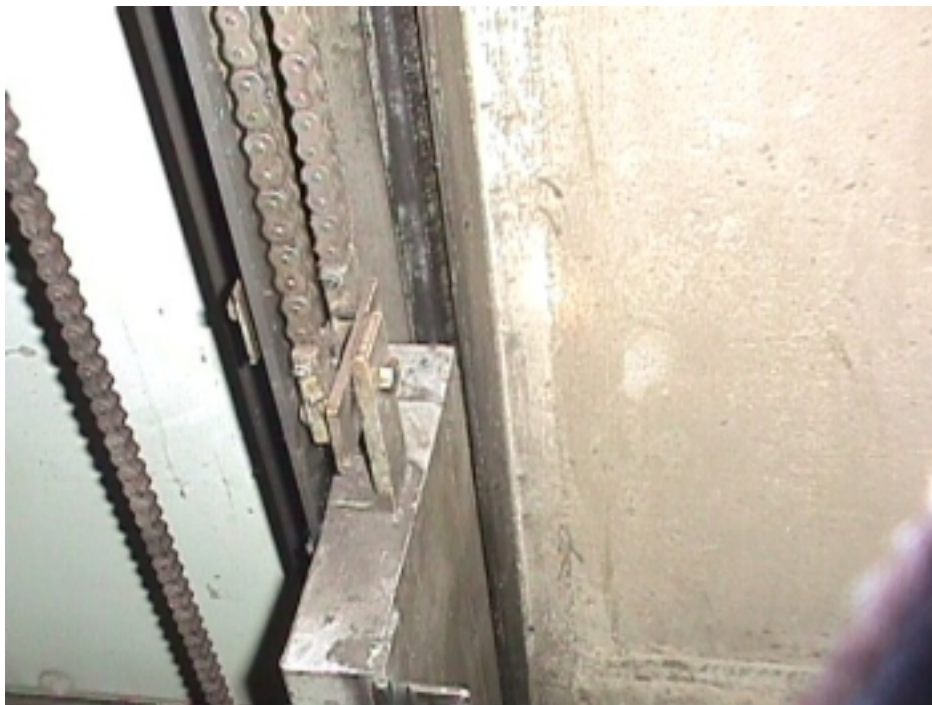
**Figure 4. Gate Counterweight Connecting Bolt Assembly**
